Project: Sumner Rockfall Protection Embankment
Date: April 2011
Client: Sue Gifford
Location: Christchurch

GREEN TERRAMESH ROCKFALL BUND

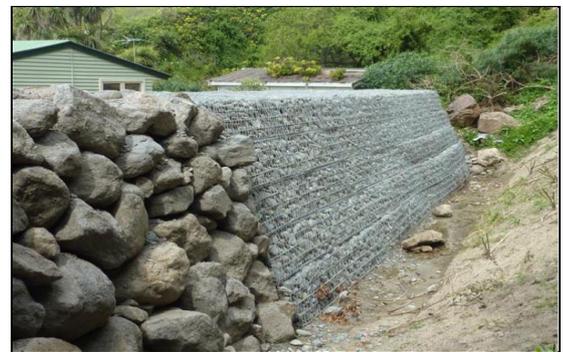
During the September 2010 Darfield earthquake of Mw7.1, a few small rocks were contained by the GTM embankment. This was the first real test for the GTM embankment. Due to the relatively small rock size and low velocity, no penetration of the embankment took place.

GTM embankment after September 2010 earthquake

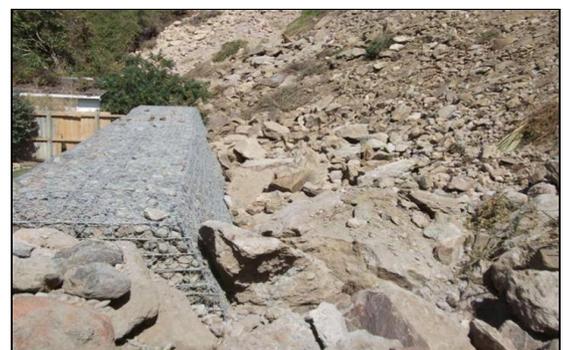
The major earthquake of Mw6.3 that struck Christchurch in February 2011 resulted in very high ground shaking around the Sumner area which provided a major test for the GTM embankment. The site location is just over 5km away from the epicenter; this has caused dislodgment of rocks from the weathered cliff giving rise to multiple rock falls with the largest rock size estimating to be up to 2.0m in diameter. Site observation confirmed that some penetration of the GTM embankment occurred on the uphill side of between 150mm to 250mm.

GTM embankment after February 2011 earthquake

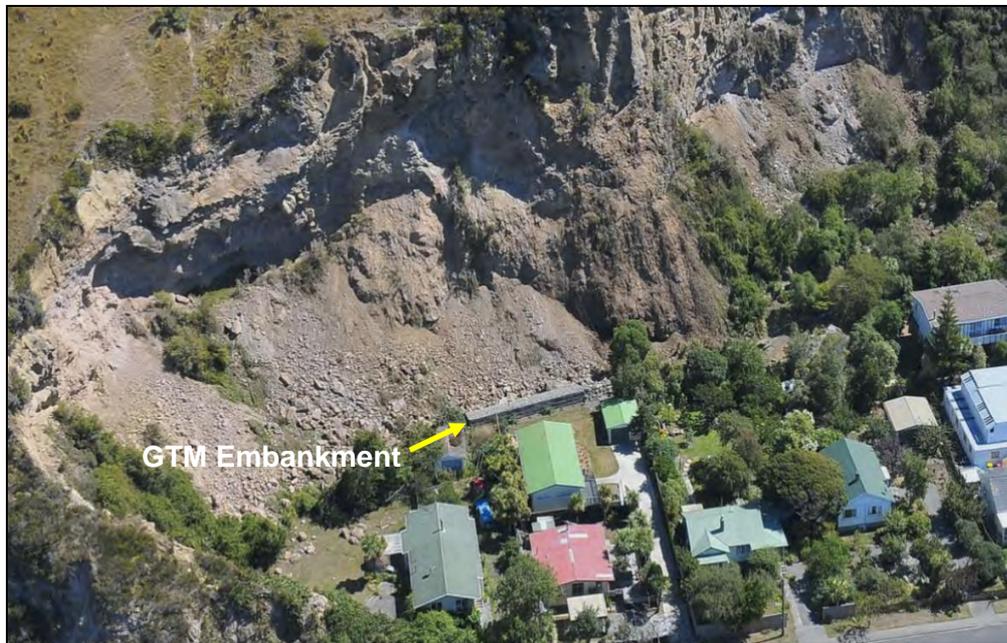
Aerial view of GTM embankment below cliff (GNS Photo-GTH_5700)

The full extent of the rockfall can be seen in the aerial photo of the site. Large rocks can be seen on adjacent properties beyond the line of the GTM embankment. (Refer to GNS Science Immediate Report Job Number 460W6303 dated 2 March 2011)

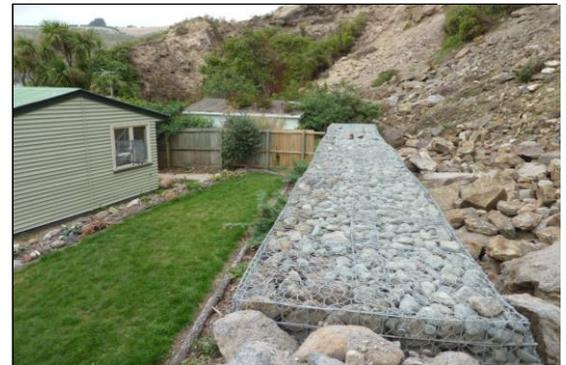
The GTM embankment showed no sign of movement and all the mesh was observed to be intact even in areas of rock penetration. No major structural damage of the house was observed with only one broken window which was caused by smaller rock fragments hitting the debris piled up to the crest of the GTM embankment and then bouncing over.

GTM embankment and house after February 2011

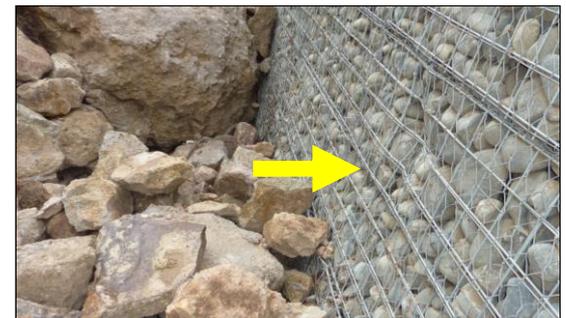
This indicates the very high energy absorption capacity of the embankment. Energy levels high energy absorption capacity of the embankment. Energy levels of between 700kJ to 2,600kJ have been estimated based on the height of the cliff and rock sizes collected by the GTM embankment.

Penetration of the GTM embankment
