## EROSION PROTECTION

In December 2021, CCX-M™ GCCM\* was used to provide erosion protection to the bank of the Viche River in Esmeraldas Province, Ecuador, to prevent water from reaching and undermining the nearby OCP and SOTE pipelines.

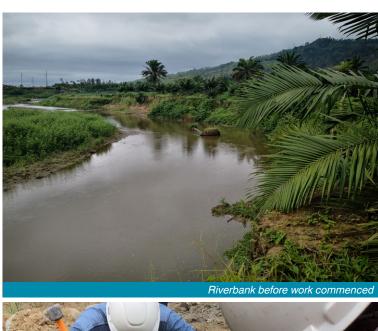
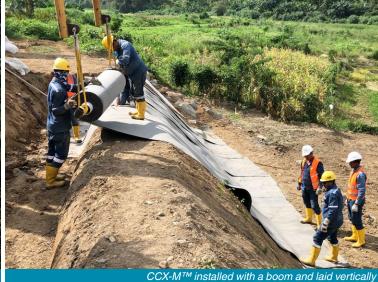
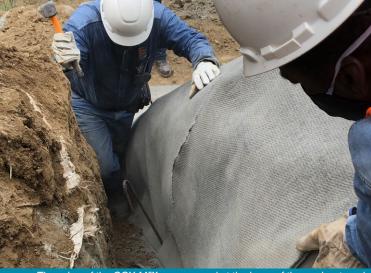
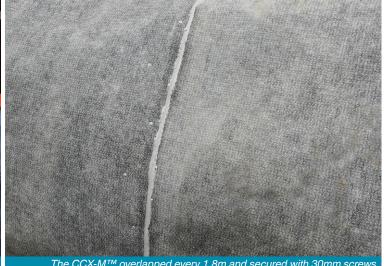
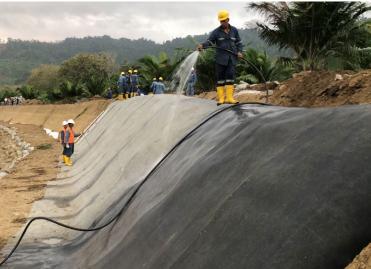
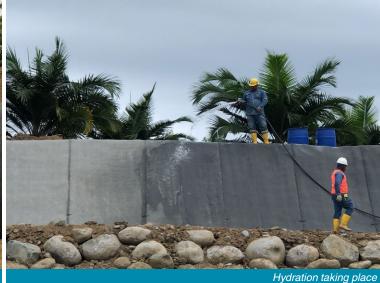
The CCX-M™ was installed with the aid of a boom truck and was unrolled and cut to the desired length by the operators. An anchor trench was excavated at the crest and toe of the slope into which the CCX-M™ was secured with 12mm thick steel pegs through each overlap. The subsequent layers of the CCX-M™ were overlapped by 100mm and joined using adhesive sealant, secured with 30mm screws in two zigzag rows every 50mm. Once the installation was complete, the CCX-M™ was hydrated. Finally, the toe trench was covered with rock giving greater weight to the CCX-M™ anchorage and backfilled with earth.

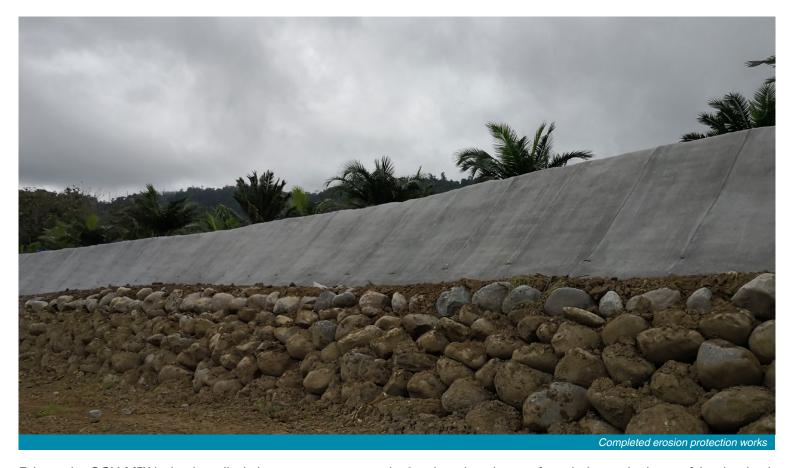
Prior to the CCX-M™ being installed, the contractor created a 2m deep breakwater foundation at the base of the riverbed, supporting a 56° slope constructed from 1.2-1.5m diameter rock. Above this a 45°, 6m long slope was profiled and lined with CCX-M™ to provide erosion protection from subsequent flooding.

1,225m² of CCX-M™ was installed in 4 days by 10 people, with the works having to be completed before the first rains came into the area (which historically occur in mid-December).
