## GEOFABRICS CASE STUDY

# GABION WALL STABILISES LANDSLIDE SITE IN COFFS HARBOUR

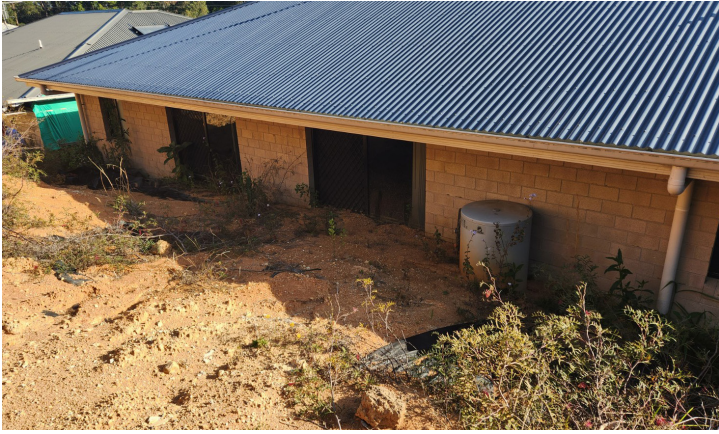
**350<sub>m²</sub>**  
gabion basket  
retaining wall

**400<sub>m²</sub>**  
reinforced erosion  
control mat installed

The site required thorough preparation, with the removal of debris around the houses and the cleaning and reinforcement of the batter slope. A total of 350 square metres of gabion baskets were installed at the base of the structure to provide foundational support, and 400 square metres of the erosion control mat was applied on the batter for surface stabilisation and protection.
