CASE STUDY:

ROSEBERY TAILINGS DAM

ROSEBERY, TASMANIA, AUSTRALIA

Teranap TP

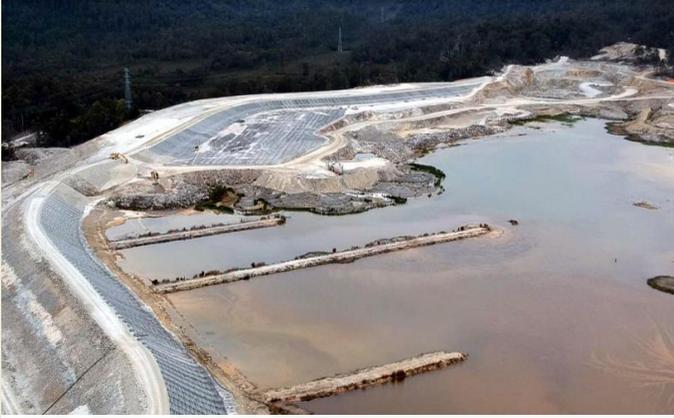
> Tailings Dam

Geotas installed 190,000 m² net area of the Teranap 531 liner and 250,000 m² of upper and lower bidim cushioning geotextile.

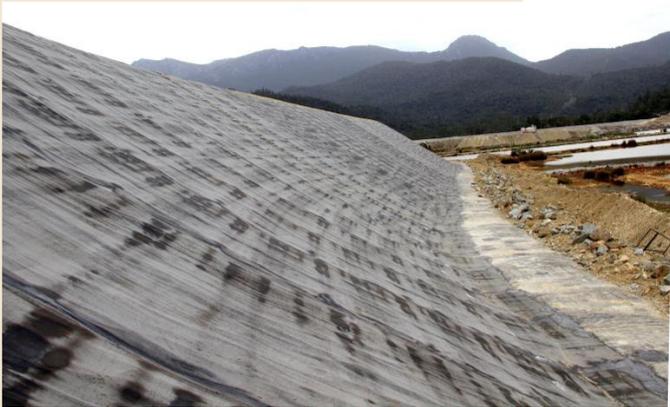
This bank of 6,000 m² took one day to install.

Geotas, with the help of Aeramix Pty Ltd, developed efficient methodology for the deployment of the liner, including a specially constructed hydraulic spreader bar attached to a 36 tonne excavator, which was used to pick up the 1,800 kg rolls, and accurately place the liner with a 200 mm overlap. This enabled Aeramix to install over 6,000 m² per day, when conditions allowed.
