# GEOFABRICS® FLAXMILL BAY COASTAL PROTECTION

CASE STUDY

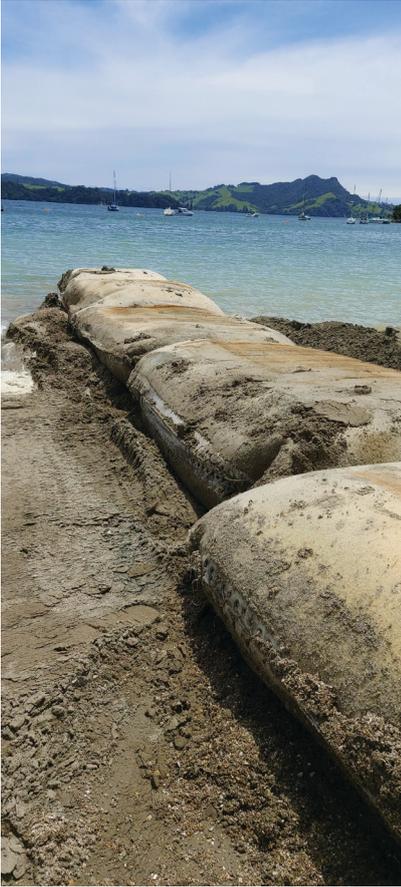
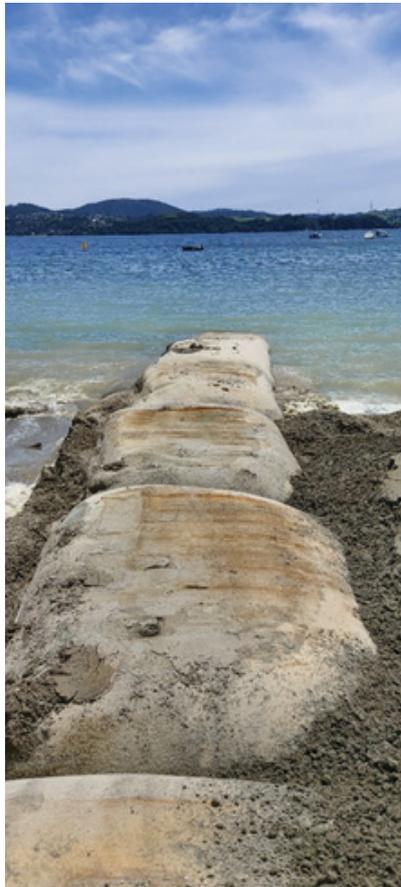
## DURING INSTALLATION

ELCOROCK was chosen to construct the three groynes as it required a shorter construction period while providing high level protection. ELCOROCK also has a strong reputation as a defensive barrier against coastal erosion and harsh environments.

The beach was closed during the construction and filling the containers, but the road and traffic flow above was unaffected. The project was completed in only a few short weeks rather than months thanks to the ELCOROCK system.
