Project: Brittan Terrace Shotcrete Drains
Date: February - April 2014
Client: Christchurch City Council
Location: Lyttleton, Christchurch

Stronger Christchurch Infrastructure Rebuild Team (SCIRT) designed a soil nail wall to repair the retaining walls in front of 16-18 and 24-30 Brittan Terrace in Lyttleton.

The shotcrete facing required a narrow profile vertical strip drain not suited to round pipe. The Infrastructure Rebuild Lyttleton 1A – Brittan Terrace contractor, Fulton Hogan Civil South installed **Megaflo® 170**.

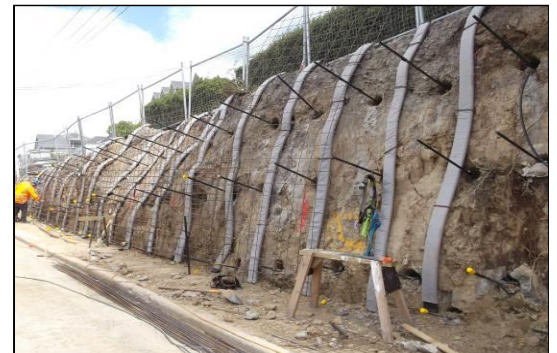
Laying of the Megaflo® drainage

Megaflo® geocomposite panel drain provides quick effective drainage. With a perforated recycled HDPE core wrapped with **bidim®** non-woven geotextile to prevent soil ingress into the drainage system.

Vertical strips of **Megaflo® 170** at 1.0m centres prevent any build up of water pressure induced on the structure.

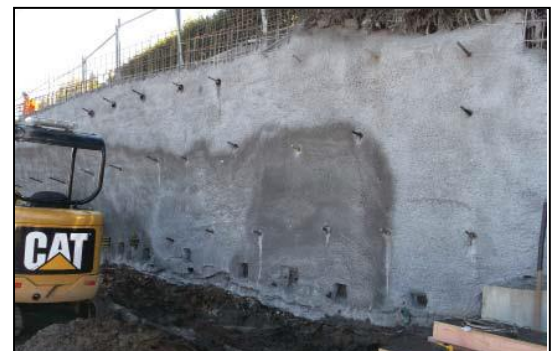
Shotcrete walls over the Megaflo®

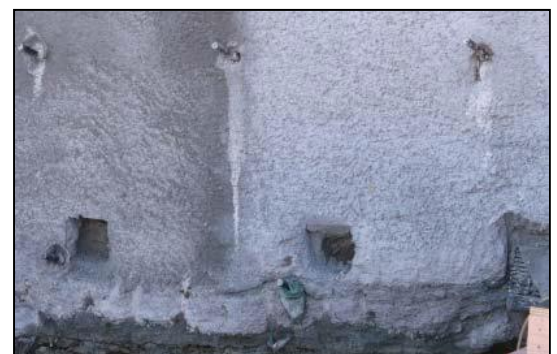
Megaflo® drainage holes through shotcrete

Creating weep holes at the base of the drainage pipe was a simple process of the installation of **Megaflo®** geocomposite panel drains behind shotcrete walls is an accepted and recognised application widely used internationally.
