CASE STUDY

Rockfall Protection

Project: Transmission Tower Protection
Date: April 2016
Designer: GHD Ltd
Contractor: Solutions 2 Access Ltd
Location: Heathcote Valley, Christchurch

RB1500Plus (MEL > 1500kJ) Catch Fence

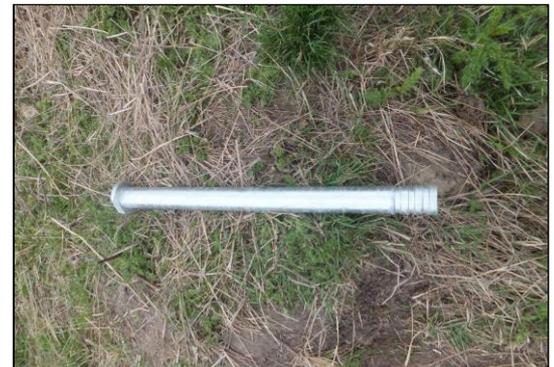
Tubular Clutch for pipe micropile foundation (Not included in the kit set)

The up slope and lateral rope anchors are normally included as part of the 'kit set' in the fence. However, foundation elements are not an ETAG 027 requirement being site specific and their design (anchor type and length) can be adjusted if necessary to accommodate the soil conditions in the engineer's design. Loading requirements are provided to the engineer for the anchor design.

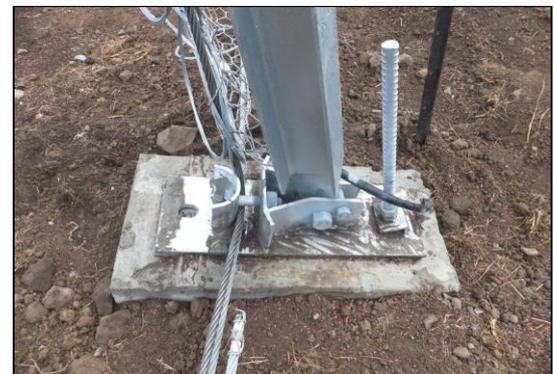
Base plate for the post

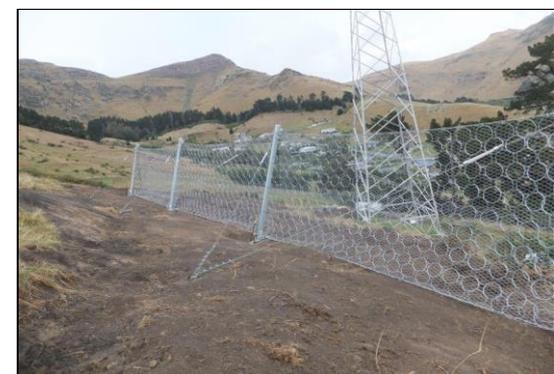
Front elevation view of fence

The total fence length was 30m with post spacing at 10m and post heights of 4.0m as shown in the image below of the completed structure.

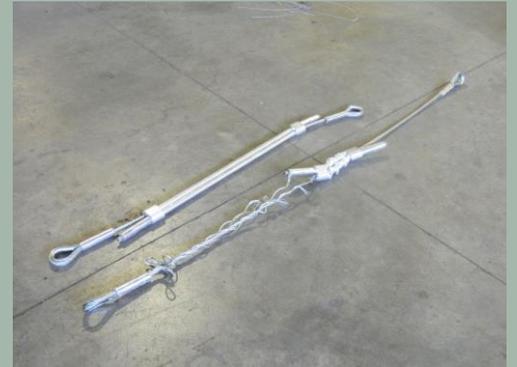
Energy Dissipater

During an impact, the system ensures that the energy of the falling rock is dissipated evenly.

Energy dissipaters fitted to the ropes help absorb impact shock loads. These Patented energy dissipaters work by absorbing the applied energy by crushing deformation and not by friction, thereby guaranteeing a better and longer lasting performance. These modular elements are factory made, reducing the risk of installation error.
