GEOFABRICS CASE STUDY

ELCOROCK SAND CONTAINERS SAVE THE MAROOCHY FROM ROCKING

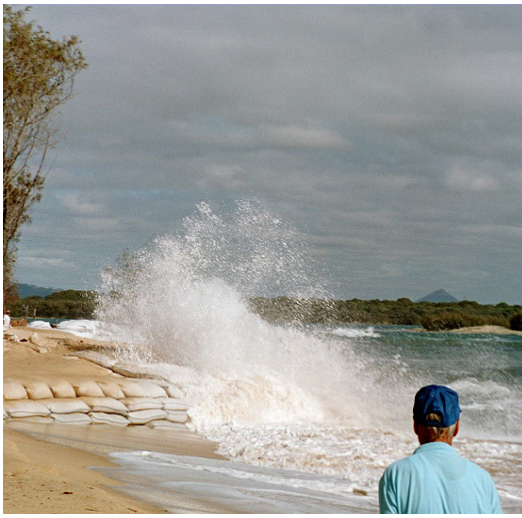
2001 EMERGENCY SEA WALL BUILT

GROYNE #1 BUILT **2001**

2003 GROYNES #2, #3 & #4 BUILT

UPGRADE OF GROYNES #3 & #4 & A NEW SEA WALL **2020**

2022 UPGRADE OF GROYNES #1 & #2 & A NEW SEA WALL

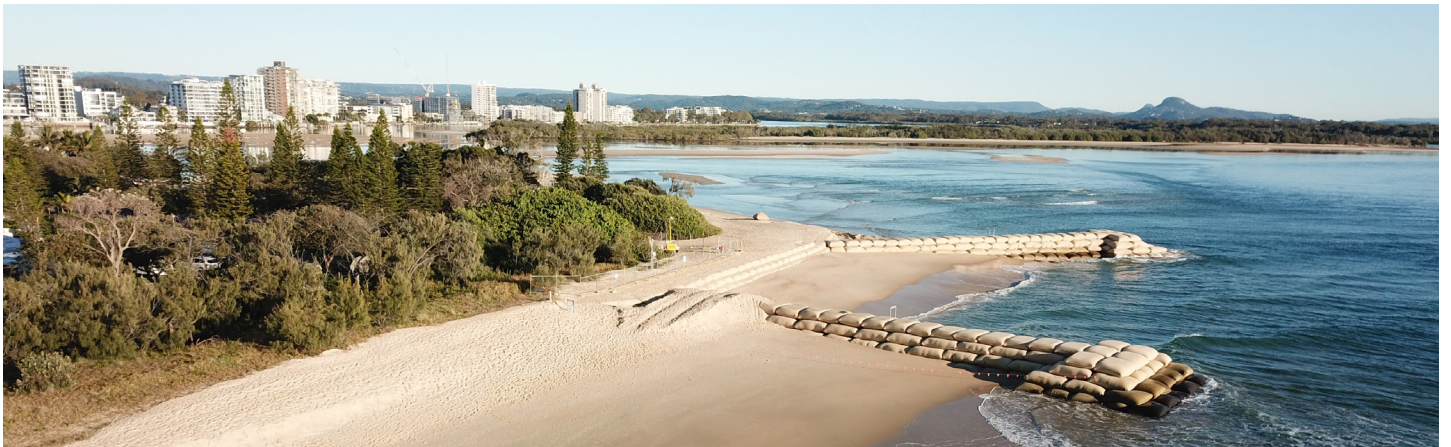
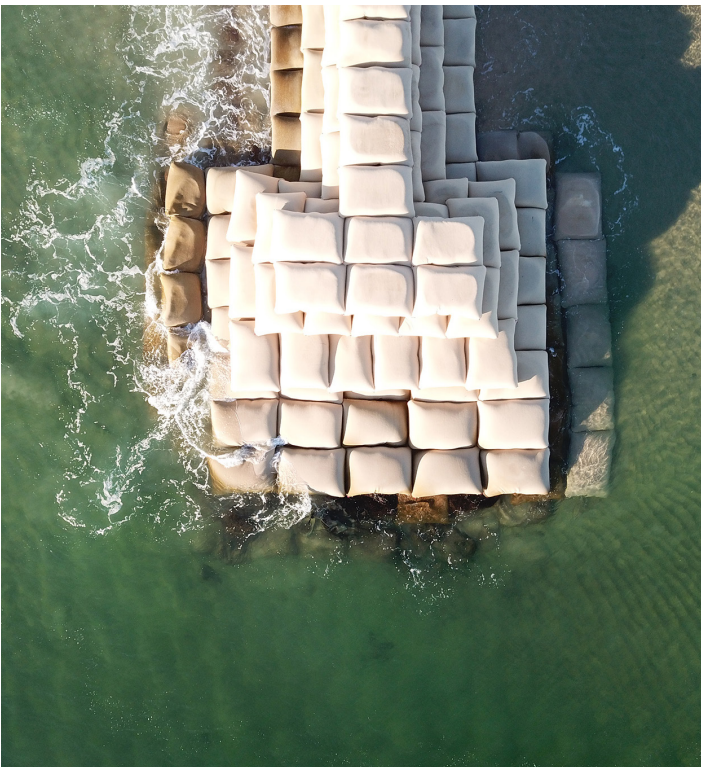
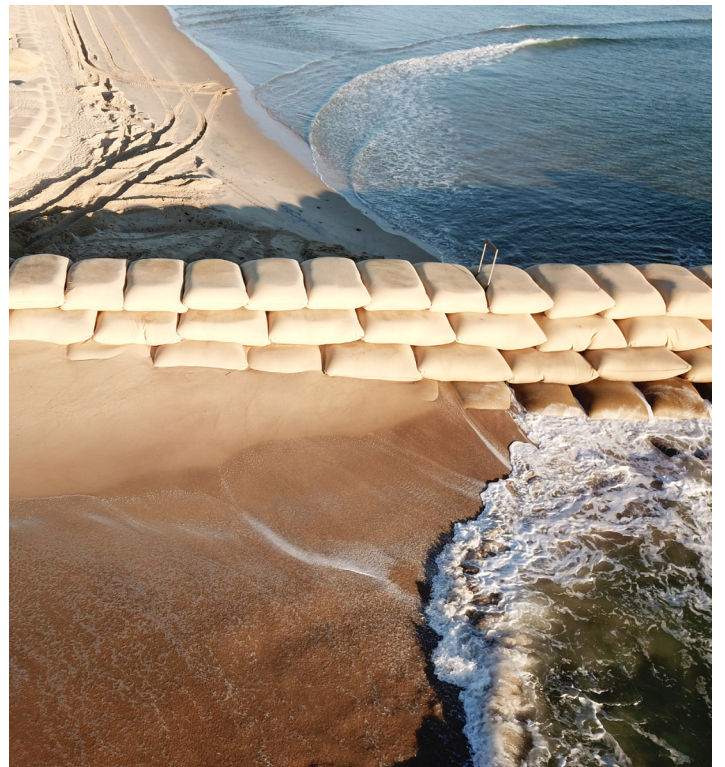
The Sunshine Coast Council officers recommended retaining the Geofabrics Elcorock Geotextile Sand Containers groynes rather than replacing with rock. The seawall was reconstructed using 1,330 Elcorock 2.5m³ containers. Groynes #3 & #4 were reconstructed using 569 of the new and larger 5.0m³ containers. Due to the increased size and mass of the container, the contractor developed modified filling and placement techniques to achieve the design outcome.
