## CASE STUDY:

# EAST GATE SLIP

**SH94, MILFORD, NEW ZEALAND  
FEBRUARY 2019**

**CLIENT: MILFORD ROAD ALLIANCE  
CONSULTING ENGINEER: GOLDER**

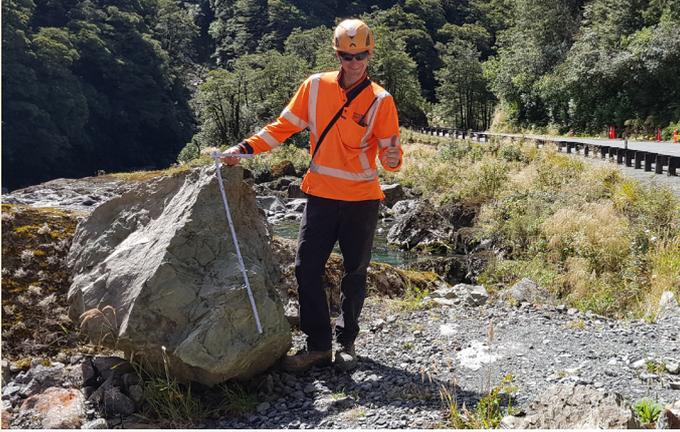
Recorded historical data shows that rockfalls at this site are between 0.2 m and 1 m in diameter.

Historical data maintained and recorded by the MRA suggest that most of the rock sizes fallen over the years range between 0.2 m up to a maximum of 1.0 m in diameter. Among many remedial measures considered for the site, the following options were suggested:

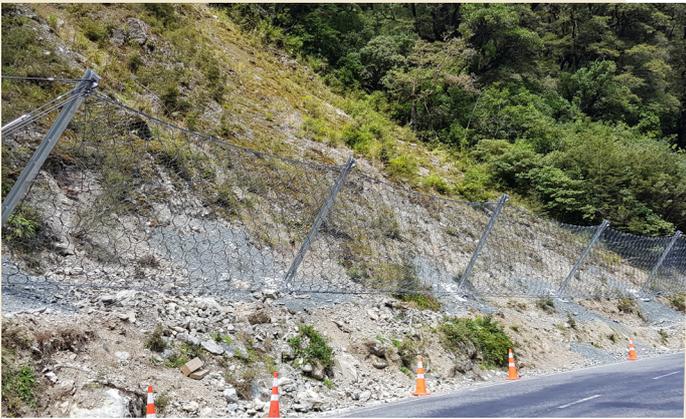
Completed 2000 kJ Maccaferri RMC200A certified fence.

The installation of the fence began with the setting out and drilling of the anchors, followed by concrete foundation for the base plates. The above ground structure (fence components) was installed by specialist abseiling team, Heads Up Ltd, upon the completion of the anchors/foundation construction. The entire process for this 4 m x 50 m long fence took two to three weeks to complete.

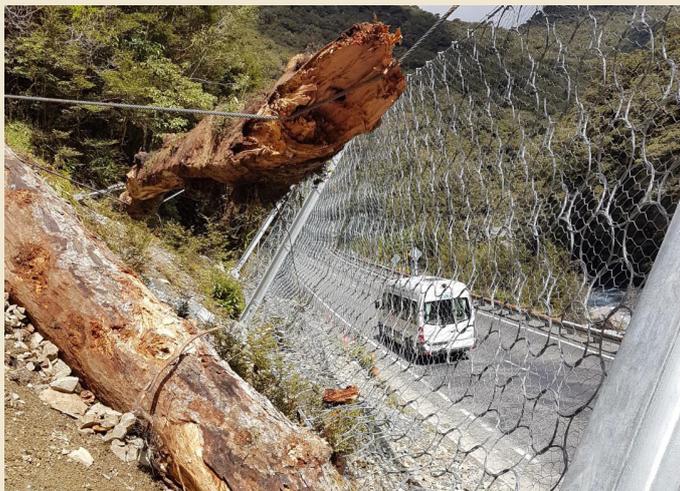
Fallen trees stopped from falling onto the road by the fence.

Immediately upon completion, the fence was impacted by fallen trees of 400-500 mm in trunk diameter. The fallen trees were successfully stopped by the fence with marginal activation of the energy dissipater, no replacement of any fence components was required as the impact energy was minor.
