# GEOFABRICS KAIKOURA OHAU POINT ROCK FALL PROTECTION

**SLOPES AND WALLS**

CASE STUDY

#### PROJECT LOCATION: KAIKOURA SH1

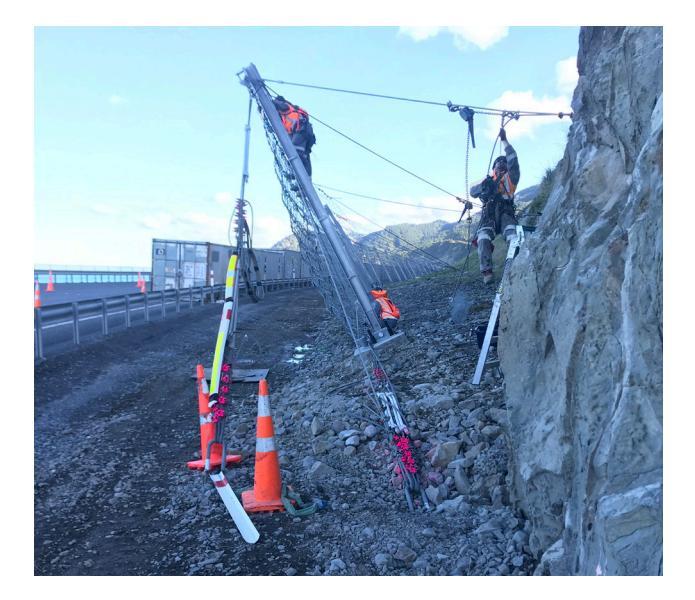
After observing multiple storms while the upslope works were in progress, it was decided that a rock fall fence was required to catch material that could bypass the catch bench and bund if it became overwhelmed in extreme events.

A Maccaferri RMC200A (MEL>2000kJ) (ETAG27 certified) rock fall protection fence was determined to be the best option for the road shoulder beside the toe of the slope for a site at Ohau Point.

This fence forms part of the hazard mitigation works as the last line of defence structure to intercept any falling rocks.

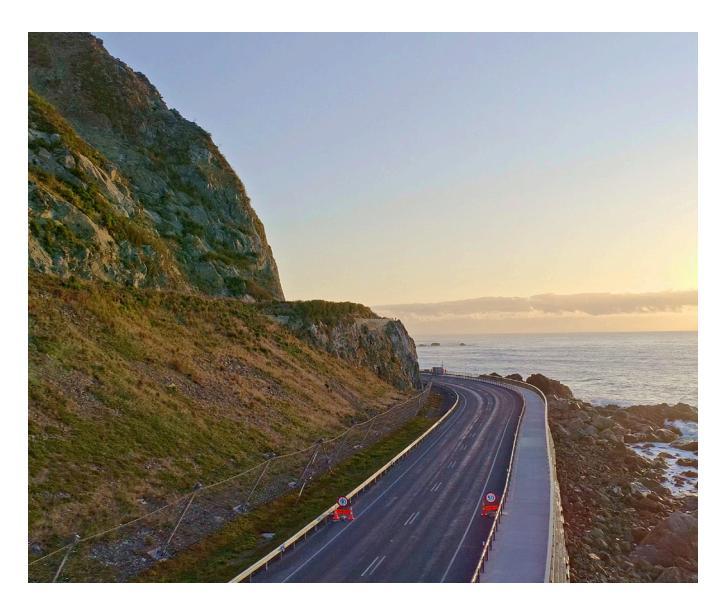
The total length installed was over 600m in total with a post height of 4.0m. The installation timeframe took place over 4.5 months.

The fences were installed with intermediate posts at every 50m section with lateral anchors at both sides of the intermediate post. This allows the fence to be repaired and maintained within a shorter span after extreme rock fall impact events.

Approximately one year after the completion of the fence installation, it was impacted by multiple rock falls after severe weather in Kaikoura. The largest boulder size was observed to be >1m in diameter with an estimated bounce height on the intercepting panel between 1.5m to 2.0m. All rocks were successfully stopped by the fence, and only minor repair to the secondary DT mesh was required for the fence to be fit for purpose again to protect the road network.
