## CASE STUDY:

## KATIKI BEACH

COASTAL EROSION, OTAGO NEW ZEALAND JUNE 2018 CLIENT: NEW ZEALAND TRANSPORT

## > Katiki Beach Slope Reinstatment

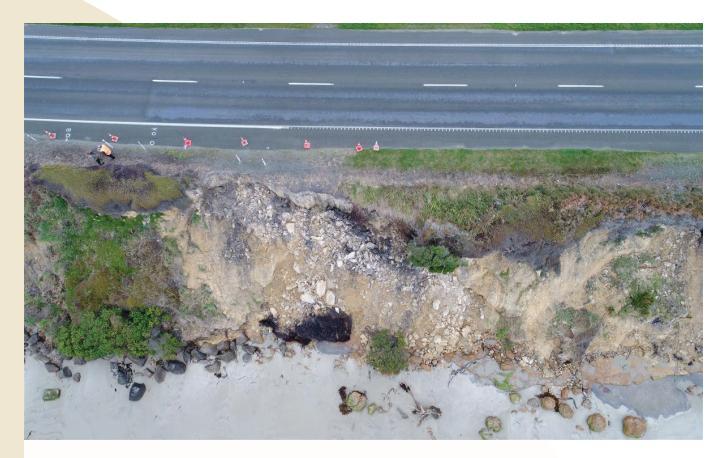
Road cracking & coastal erosion before the project commenced

More significant erosion of the site occurred after this rain event, resulting in edge seal cracking within 1.0 m of the southbound lane and cracks present over approximately 35 m length of road.

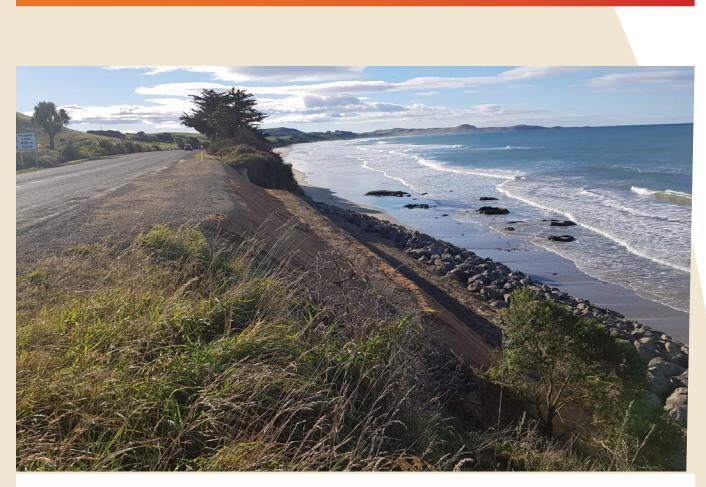
Road view after project completion

The final shoulder was reinstated to a minimum width of 3.0m from the edge of lane to allow future paved access for bicycles, and a rope barrier, with appropriate ground behind it.

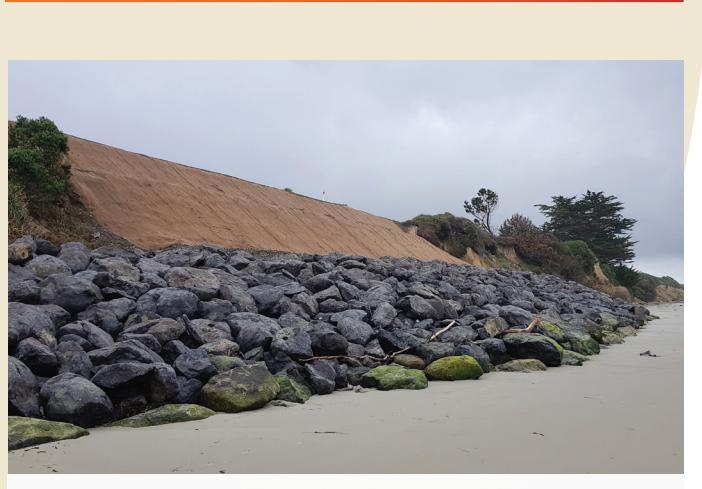
Beach view after project completion

The design solution accepted by the client and installed by SouthRoads was a 9 m high Miragrid reinforced structure to reinstate the eroded embankment. Further protection consisting of 2 m thick armour rock at the toe extending 1 m below the lowest historic beach level. The slope was constructed using bidim A64 geotextile, TenCate Miragird GX 100, a top layer of BioMac Coir mat with rip-rap at the toe.
