GEOFABRICS CASE STUDY

GABION-FACED WALL DELIVERS LONG-TERM STABILITY FOR SOUTH AUSTRALIAN BRIDGE

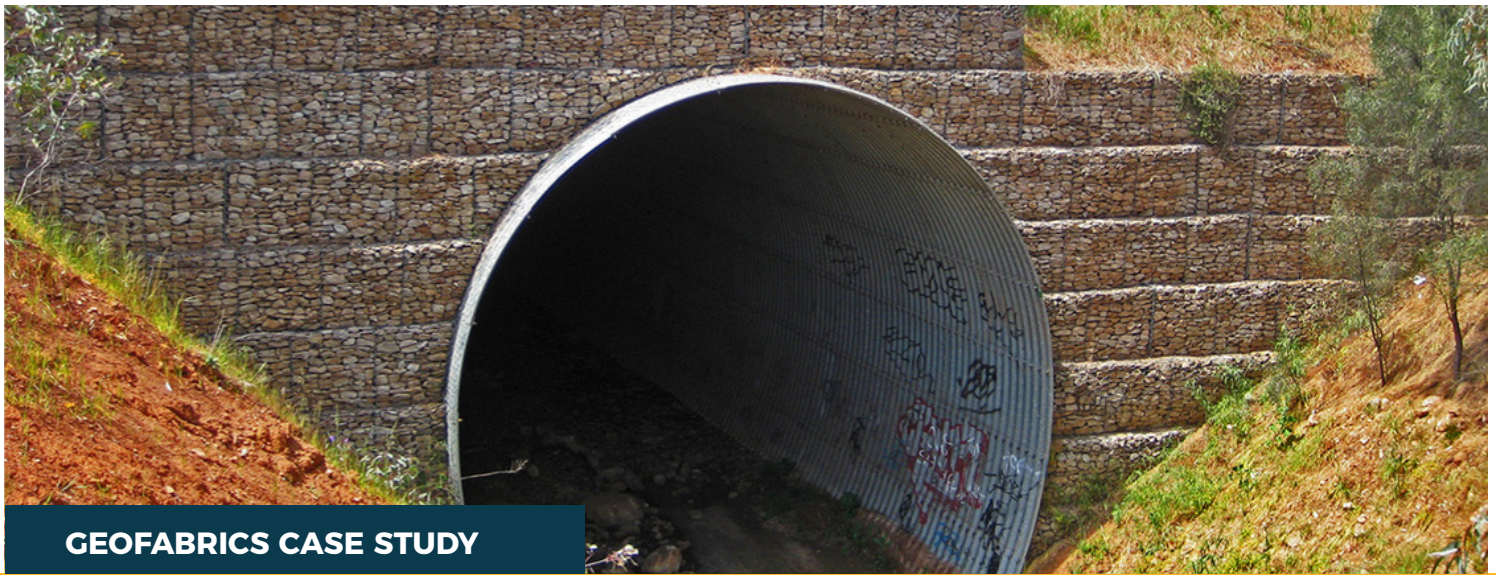
An 8-metre-high multi-plate steel horseshoe arch was constructed on concrete footings, paired with vertical Mechanically Stabilised Earth (MSE) wingwalls upstream and downstream. The MSE wall featured gabion facings with integral polymer-coated woven mesh soil reinforcement extending six metres into the compacted select fill behind the structure. The gabion facing was rock filled with lids left open temporarily to act as a safety fence, while a non-woven geotextile filter cloth provided separation and filtration between the facing and backfill, mitigating hydrostatic pressure.

The wire mesh gabion system accommodated potential subsidence and soil movement without failure, making them ideal for the unstable creek embankments. Construction involved in-situ assembly of multi-plate steel sections embedded in concrete footings at the creek bed. Over the years, inspections in 2008 and 2019 confirmed the polymer-coated mesh remained in excellent condition with no signs of corrosion or stress, validating the long-term effectiveness of the solution.
