GEOFABRICS CASE STUDY

HIGH-PERFORMANCE GEOTEXTILE SOLVES WEBER ROAD SUBGRADE ISSUES

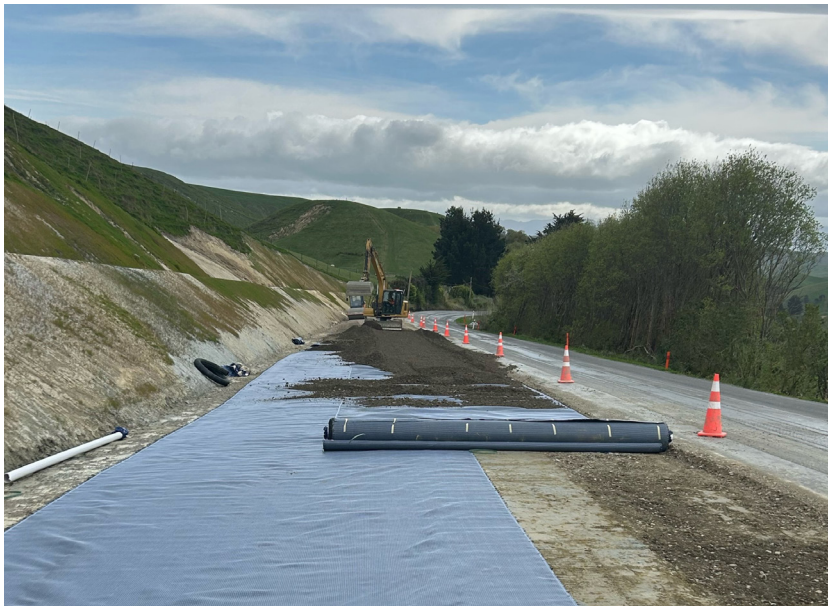
**Moisture
control
and subgrade
stabilisation**

**6,750 m²
H2Rx
installed**

To prepare the ground for installation, light grading was undertaken to remove surface irregularities, with care taken to avoid using heavy equipment that might disturb the soft subgrade. Mirafi H2Rx geotextile rolls were then installed along the alignment using light machinery. The geotextile was laid in the direction of traffic flow, with longitudinal seams overlapped by 300 – 450 millimetres and cross-roll overlaps staggered to minimise potential weak points.

A total of 6,750 m² of H2Rx geotextile was installed to evenly distribute loads and reduce deformation across the soft, moisture-sensitive subgrade. Its unique wicking action continuously draws moisture away from the road base, preventing saturation and protecting the pavement's structural integrity. This transformed the site into a durable, high-performing roadway that effectively addressed the initial ground conditions.
