CASE STUDY

Double Twist Mesh

Project: Haven Rd Slip Repair
Date: March – Sept 2013
Client: Haven Partnership
Location: Nelson

Green Terramesh

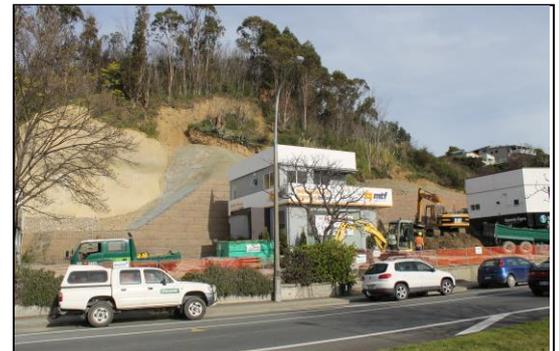
Installation of Green Terramesh Slope

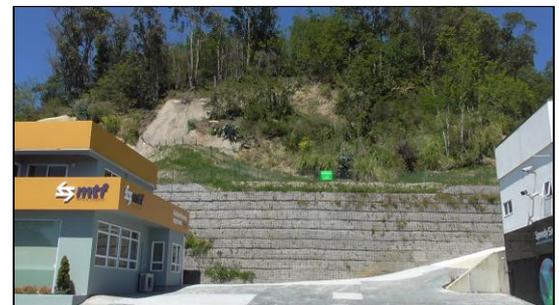
Green Terramesh slope supporting the slip area above

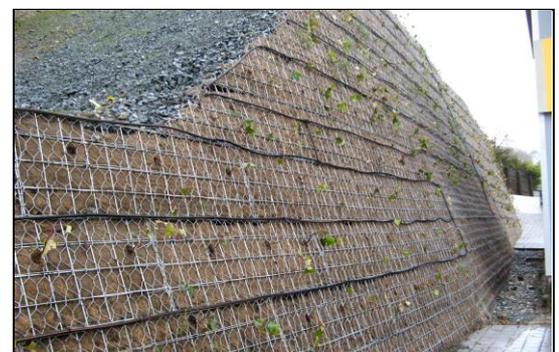
Close up of Green Terramesh Slope
