CASE STUDY

Geocontainer

Project: Shoreline Protection Lake Moawhango
Date: April - May 2009
Client: Genesis Energy
Location: Lake Moawhango

ELCOROCK® Bags

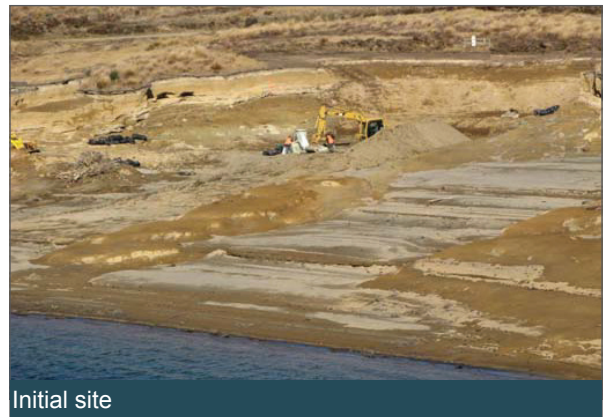
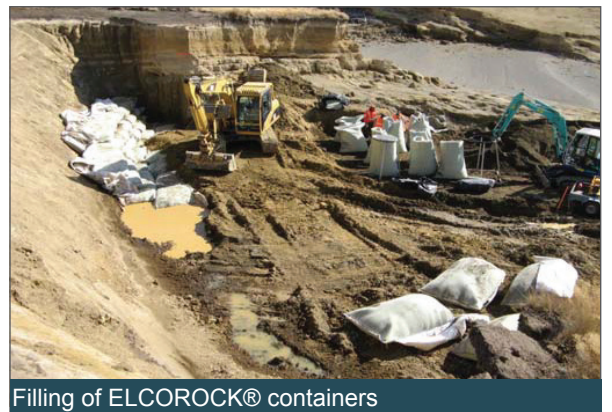
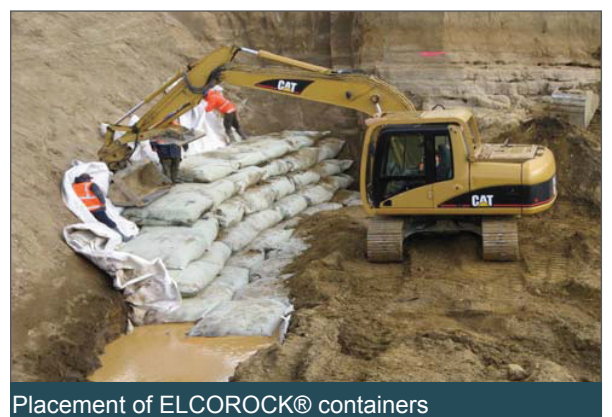
Genesis Energy has a hydro dam located at the southern end of Lake Moawhango. They have access to the dam via a road (part of the earth dam bund), which passes through the Army Training ground forming part of the Waiouru Military Camp. Frequent storms on the lake generate waves causing erosion of the ash layers that form the shoreline around the lake, threatening the access road.

ELCOROCK® containers are manufactured from a specialist UV stabilised composite of non-woven heavy weight geotextiles and developed by ELCO Solutions as a flexible alternative to “hard rock” solutions for long term exposure in coastal and shoreline works. They can be filled with local sand and silts minimising the environmental impact.

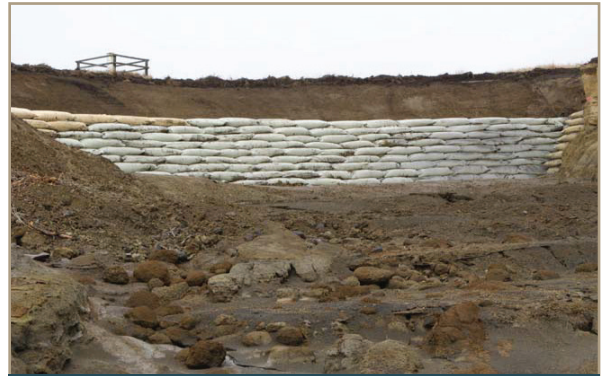
Completed section prior to erosion mat placement

Due to weather delays from snow falls as well as live Army firing exercises, the contract was limited to 4 weeks. During this period 800m² of **ELCOMAX®** geotextile was placed and 507 **ELCOROCK®** 2RP 0.75 m³ containers were filled and installed on 2 sites. Prior to the placement of the ElcoRock containers, **ELCOMAX®** geotextile was installed to create the separation layer to the structure to limit any residual erosion of the ash soils below the containers. The contractors were able to achieve an installation rate of between 30-40 containers per day which allowed them to complete the works well within the tight deadline prior to the filling requirement of Lake Moawhango for generation of hydro power.
