Project: Tensar RE Wrap Around Slope
Date: August – September 2014
Client: NZTA
Location: SH2, Te Mahanga, Hawkes Bay

Tensar RE500 Geogrid

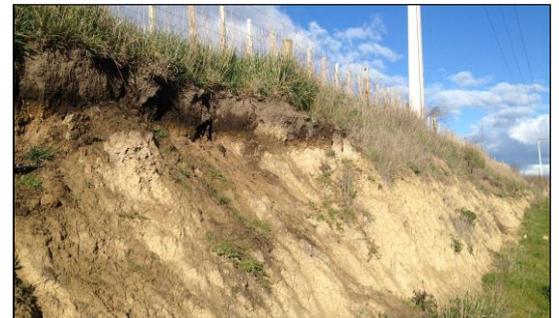
Eroding bank

A south bound passing lane was constructed along SH2 near Te Mahanga, south of Hastings during February/March 2013. The lane widening was subject to compulsory acquisition of land and only a limited amount of land was able to be purchased. This resulted in steep batter slope which started to erode under the very thick topsoil layer.

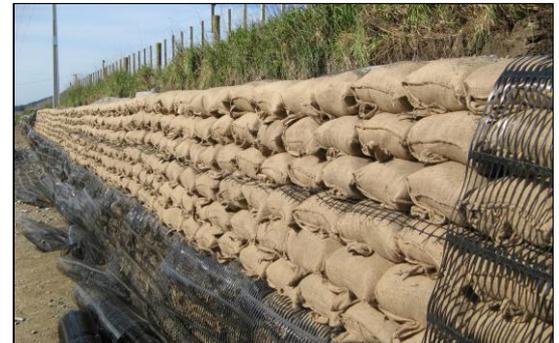
Hessian bags and Tensar RE geogrid wrap around

A vegetated solution was required to help retain and prevent further erosion back into the owners land. **Tensar RE500** uniaxial geogrid is a commonly used in the construction of wrap around reinforced soil slopes. These slopes can be constructed using formwork or in this instance with topsoil filled hessian bags which are then hydro seeded. After preparing the slope batter **Enkadrain**, a composite sheet drain was placed against the cut slope as a drainage blanket to intercept groundwater, with subsoil collector drains placed along the base. **Tensar RE500** geogrid spacing was set at 500mm centres, with a secondary geogrid (**Tensar SS20**) at midpoint to improve face stability.

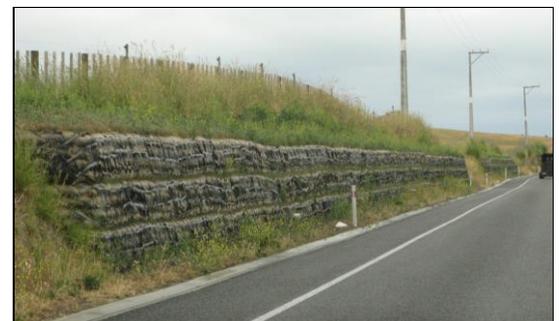
Completed project

This was the second NZTA site where the contractor had used **Tensar RE** product, the first site was at the Aropoanui Road intersection with SH2 15km south of Lake Tutira. This was also a south bound passing lane construction. The contractor found the product relatively easy to use and would not hesitate to use it again. Vegetation once established on this site will make it blend in with the surrounding area. Both NZTA and the land owner are satisfied with the outcome.
