Project: Piako Rd
Date: December 2013
Client: Waikato District Council
Location: Gordonton

Tensar TriAx®

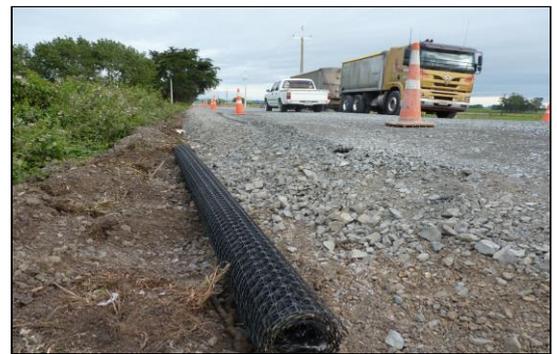
Piako Rd prior to construction

The area of Waikato between Hamilton and Morrinsville suffered from very deep peat deposits making road construction in the area very difficult and harder to maintain. Over the summer of 2013, the area suffered from shrinkage due to the drought and subsequent heat which caused damage to several roads through this area. Waikato District Council had tried many solutions, including chemical stabilisation and various reinforcing and stabilisation geogrids to address this ongoing issue with mixed success.

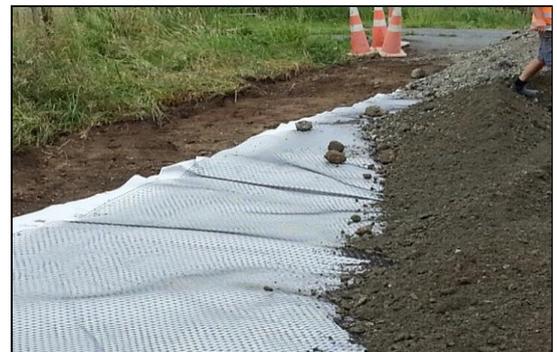
Laying of bidim® and Tensar TriAx®

Tensar TriAx® 170 was chosen for the lower layer due to its increased robustness which was needed over such soft underlying soils. This overlaid by 300mm depth of GAP65, followed by **Tensar TriAx® 160** before the final 200mm base layer of TNZ M4 was installed.

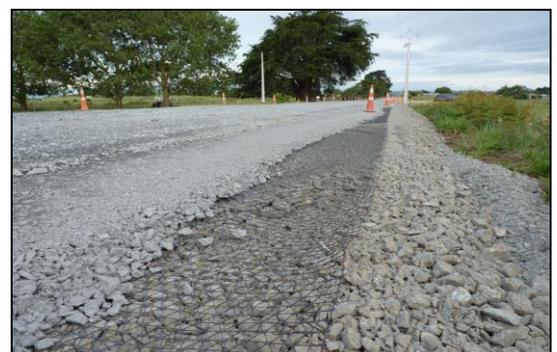
Tensar TriAx® being laid with aggregate
