GEOFABRICS CASE STUDY

PROTECT STORAGE BUNDS FROM EROSION WITH CONCRETE CANVAS

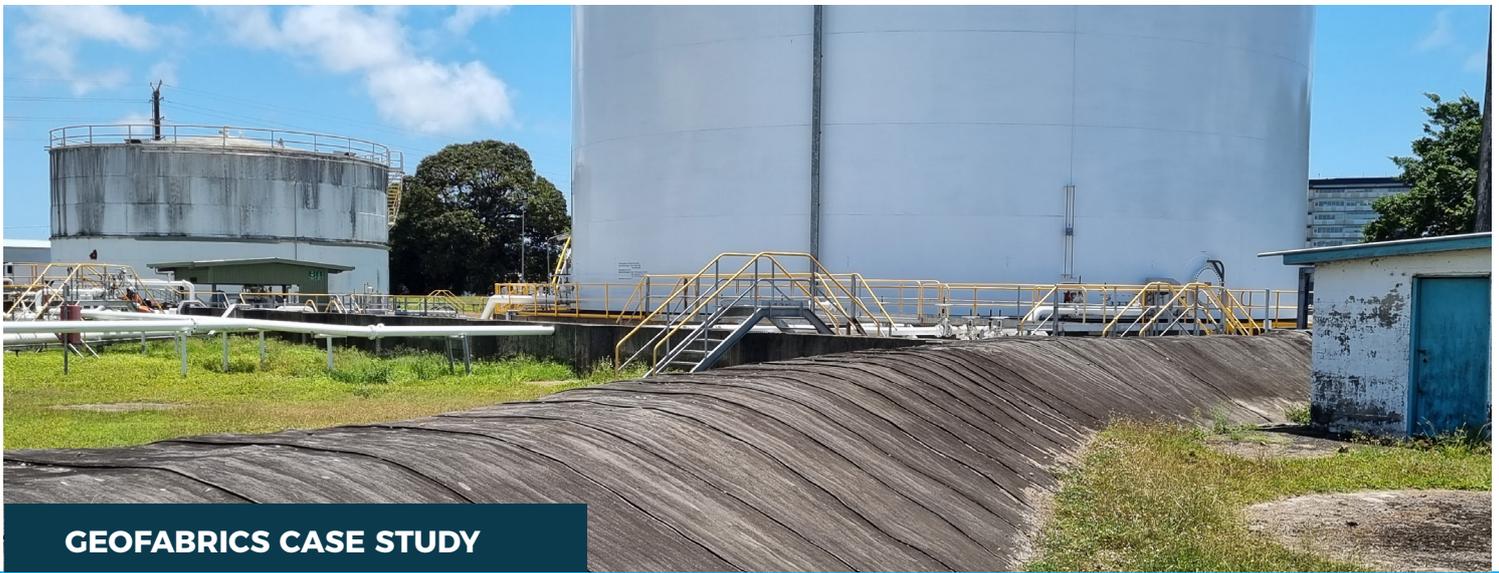
Concrete Canvas GCCM was used to line a bund around the petrochemical storage tanks providing hard armour weathering protection of bunds from erosion and acting as an effective weed suppressant, also protecting against animal damage.

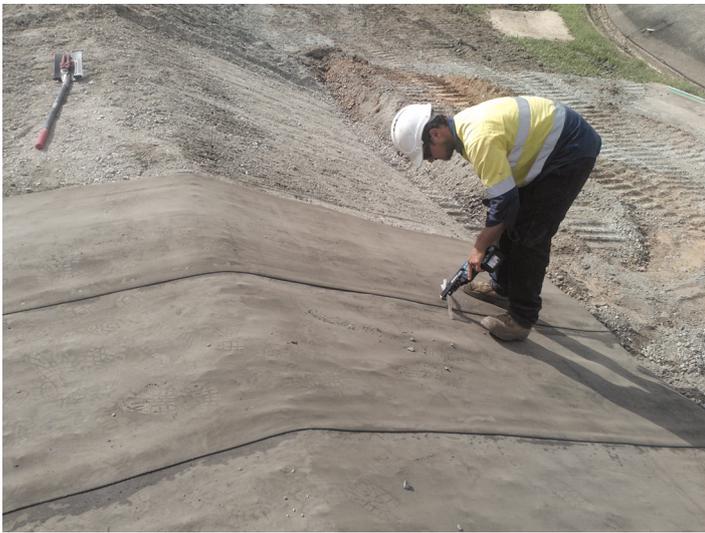
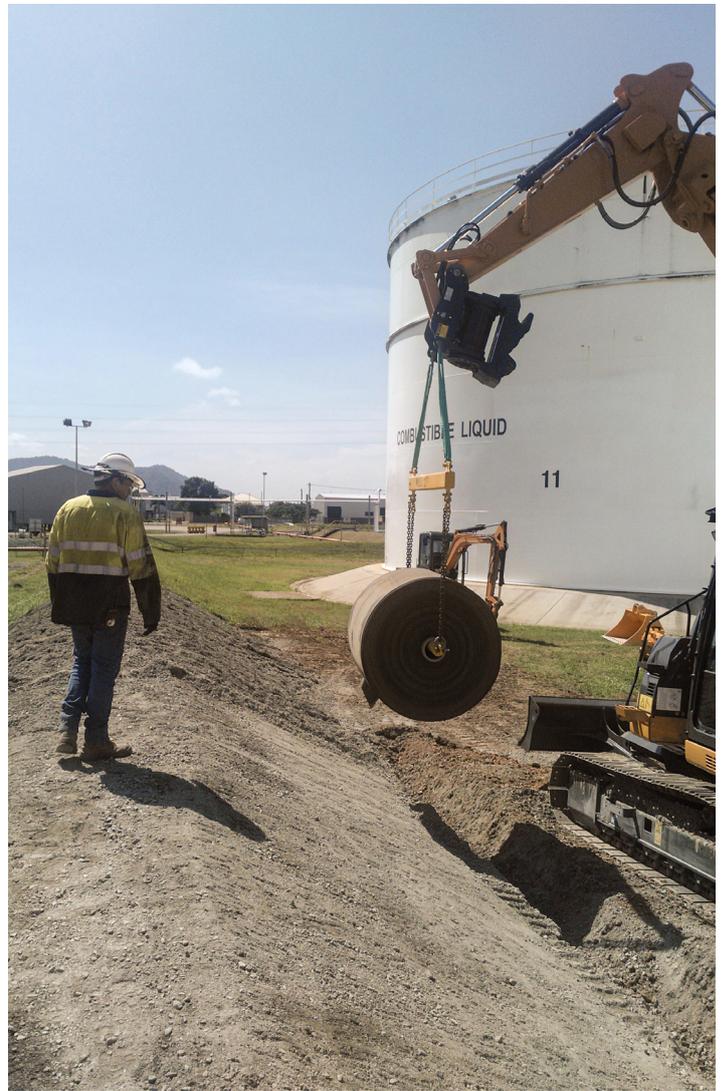
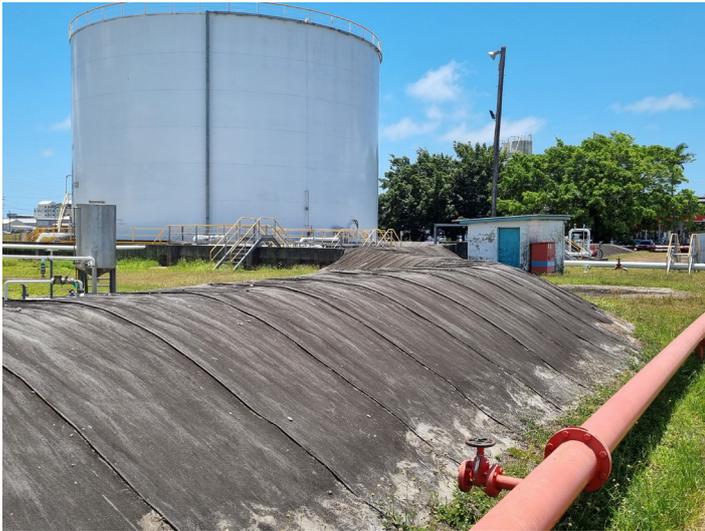
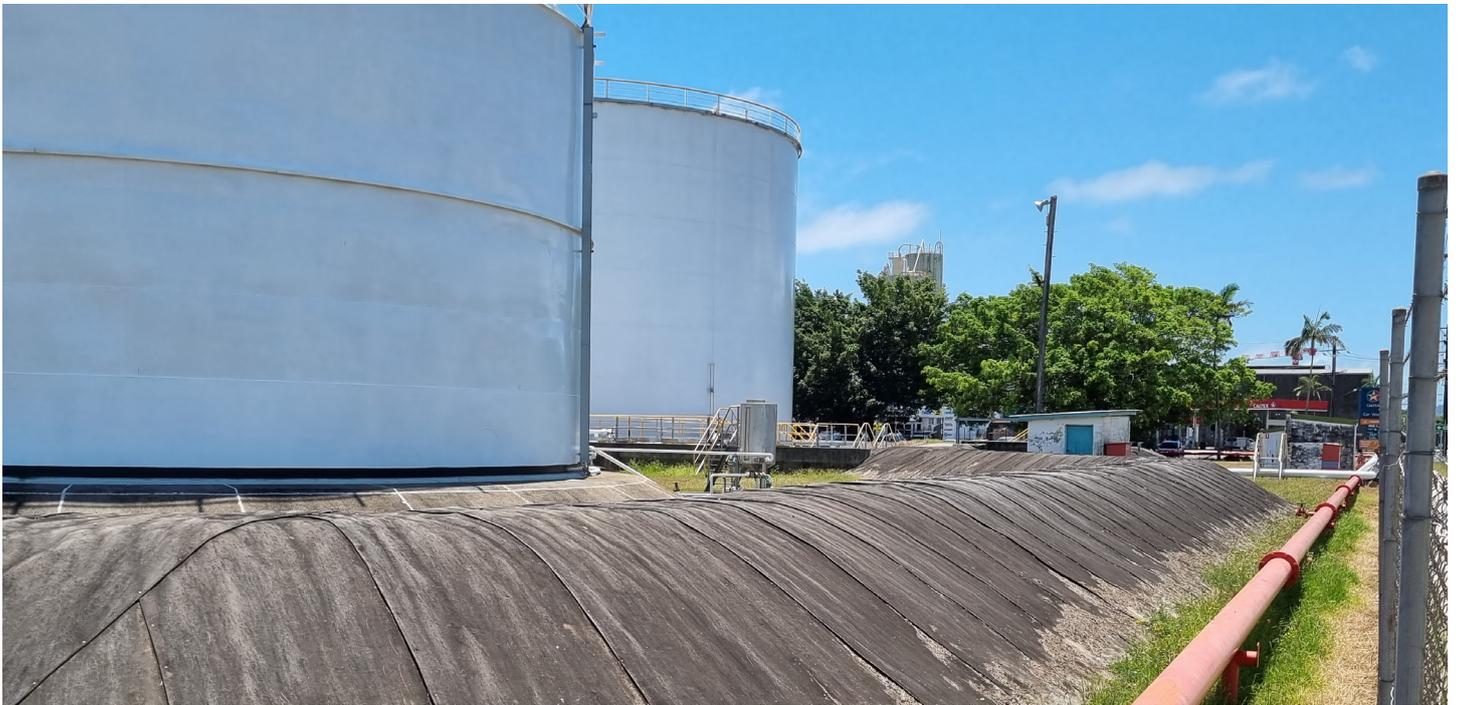
CC5 was delivered to the site in bulk rolls and deployed using a 14-tonne excavator and spreader beam. Once captured into the anchor trenches, the edges of the CC5 were backfilled with the existing soil. When positioning subsequent CC layers, they are overlapped by 100mm and jointed. Once the installation was complete, a water trunk was supplied to hydrate the CC5. The Concrete Canvas was hydrated 3 times at 20-minute intervals at the end of each day.

A total of 3,000m² of CC5 was installed in 8 days by a team of 5 labourers and 1 excavator, working 8 to 10 hour days. The project was successful, eliminating erosion and regular maintenance operations. With the installation of Concrete Canvas, the maintenance cost has now been reduced to zero and the bund is permanently protected against erosion, even after several recent cyclone events.
